**Attics: Problems and Solutions**

SeaBEC Meeting

March 15, 2018

Presented by: Lorne Ricketts | M.A.Sc., P.Eng.

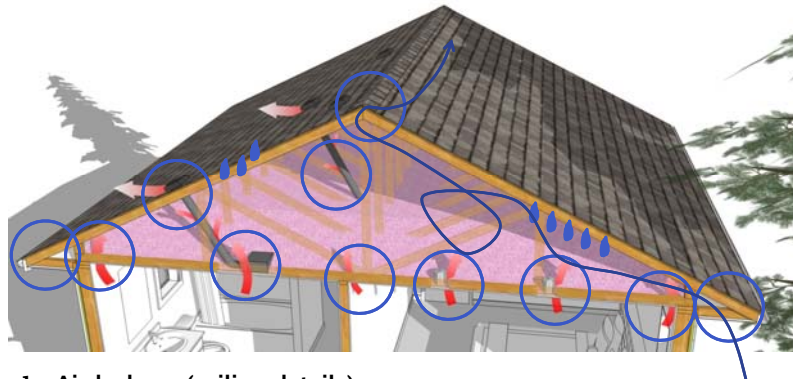
## Where are we Seeing the Biggest Issues?

1. Air leakage (ceiling details)
2. Exhaust duct leaks & discharge location (roof, soffit, or wall)
3. Inadequate venting provisions (amount, vent location, or materials)
4. Outdoor moisture: night sky condensation on underside of sheathing
5. Wetting through shingles/roofing (tipping the moisture balance)

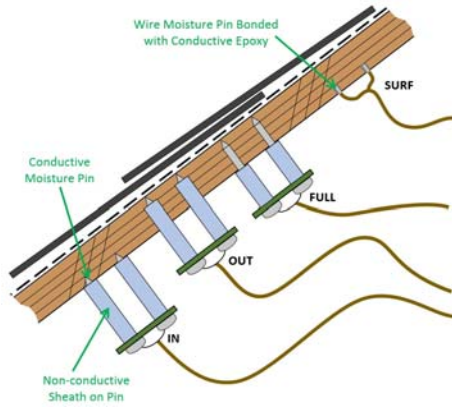
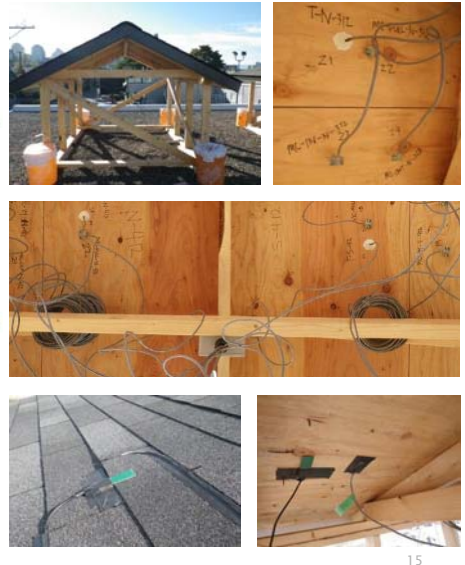
### Monitoring Equipment & Sensors

Moisture Content, Temperature, Relative Humidity and surface Condensation sensors – north and south slopes x 4 huts

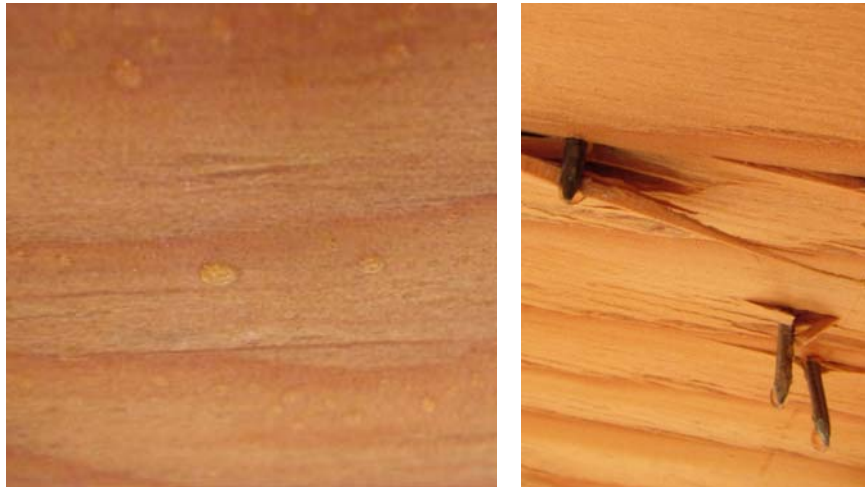
### What Makes the Sheathing Wet?

Night sky condensation!  
(Important: It happen when all moisture sources eliminated.)

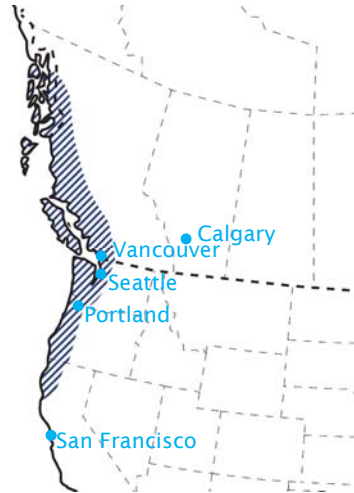
## A Localized Problem...

- ▨ High Risk Climate for  
Night Sky Radiation  
Attic Moisture Issues

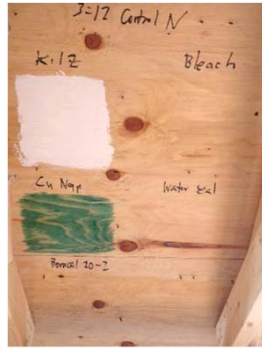
When Applied

Fungal Growth observed is Cladosporium

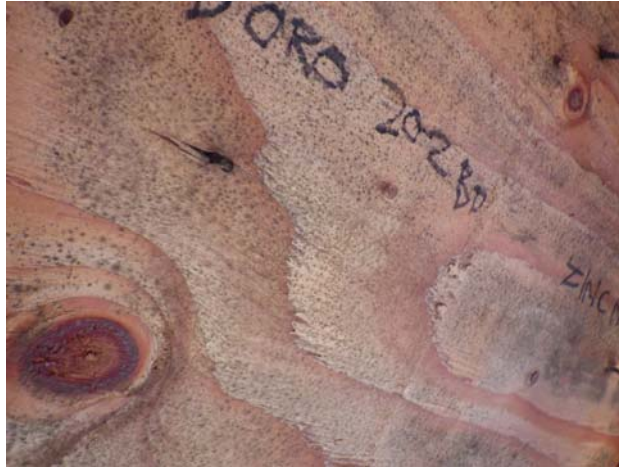
### Wood Preservative & Fungicide Treatments

The best decay fungicide looked okay in years 1 and 2 - but not in year 3

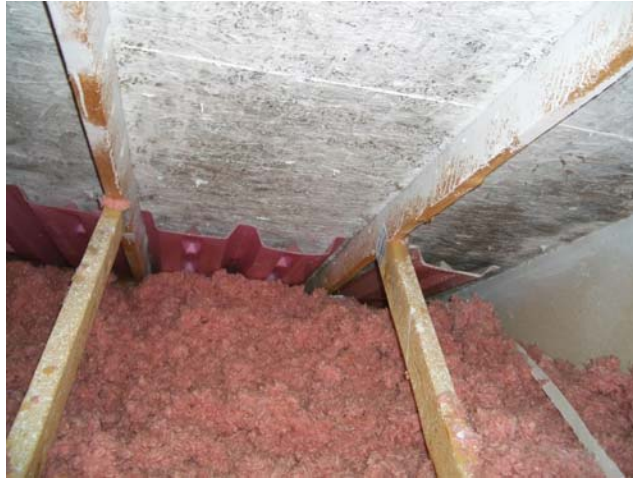
### A Caution with Surface Treatments

Mold can re-grow on surface of encapsulating paints.
